# Nondestructive Crack Detection in a Fuel System Component

2010 Aircraft Airworthiness & Sustainment

Ajay Koshti, Norman Ruffino, NASA JSC

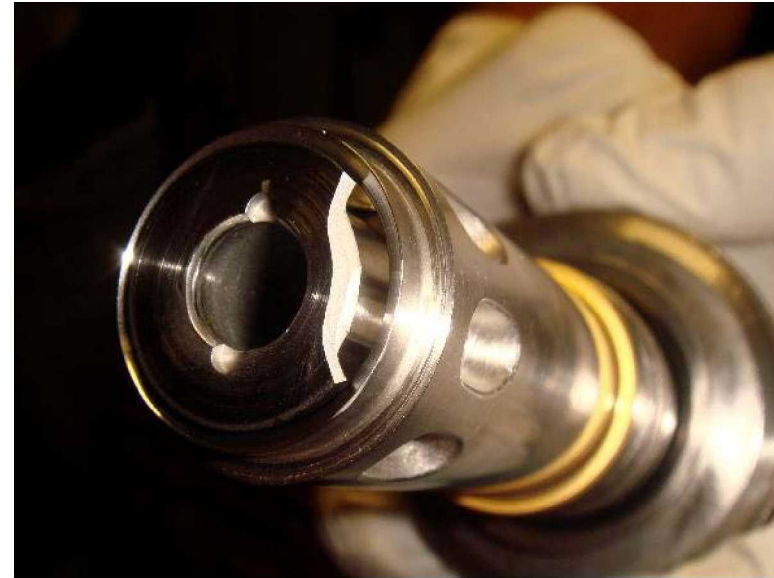
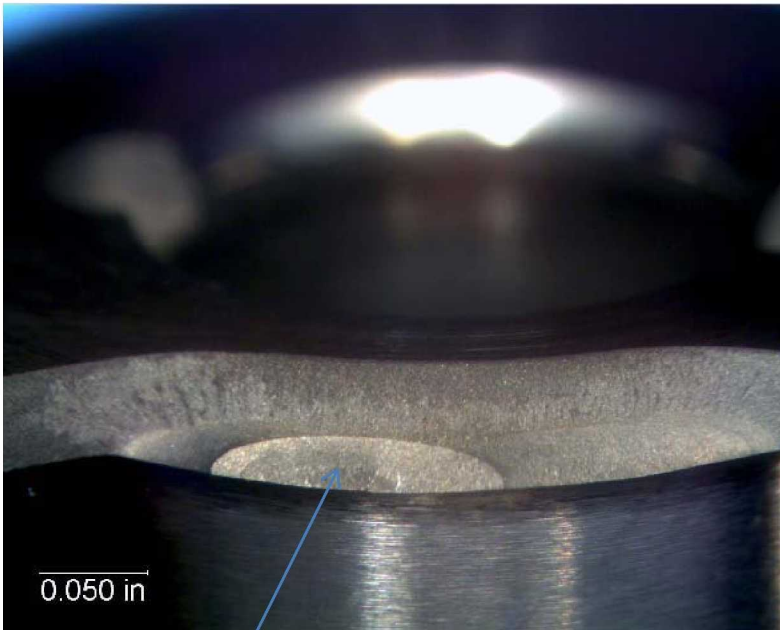
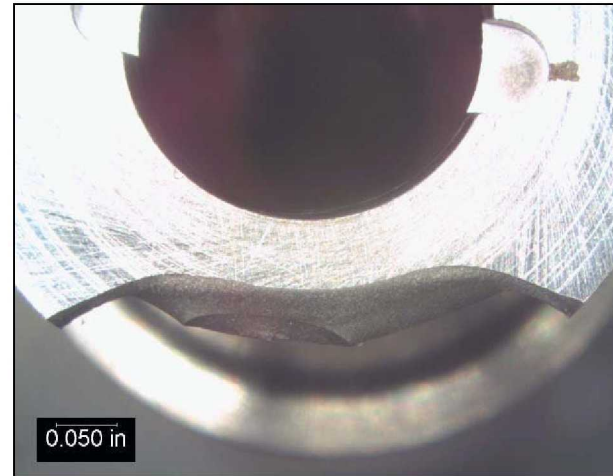
Fracture surface

Cause: High cycle fatigue during several launches. Crack formation and growth.  
Typical surface crack opening = 0.25 micron

- SEM evaluation concluded poppet failed due to high cycle fatigue
  - Several unique “thumbnail” features
  - Multiple loading events
  - Transgranular
  - Unsure of effect of hydrogen, but not significant contributor (testing in work)
  - Material change recommended
  - It is believed that failure did not occur within one flight

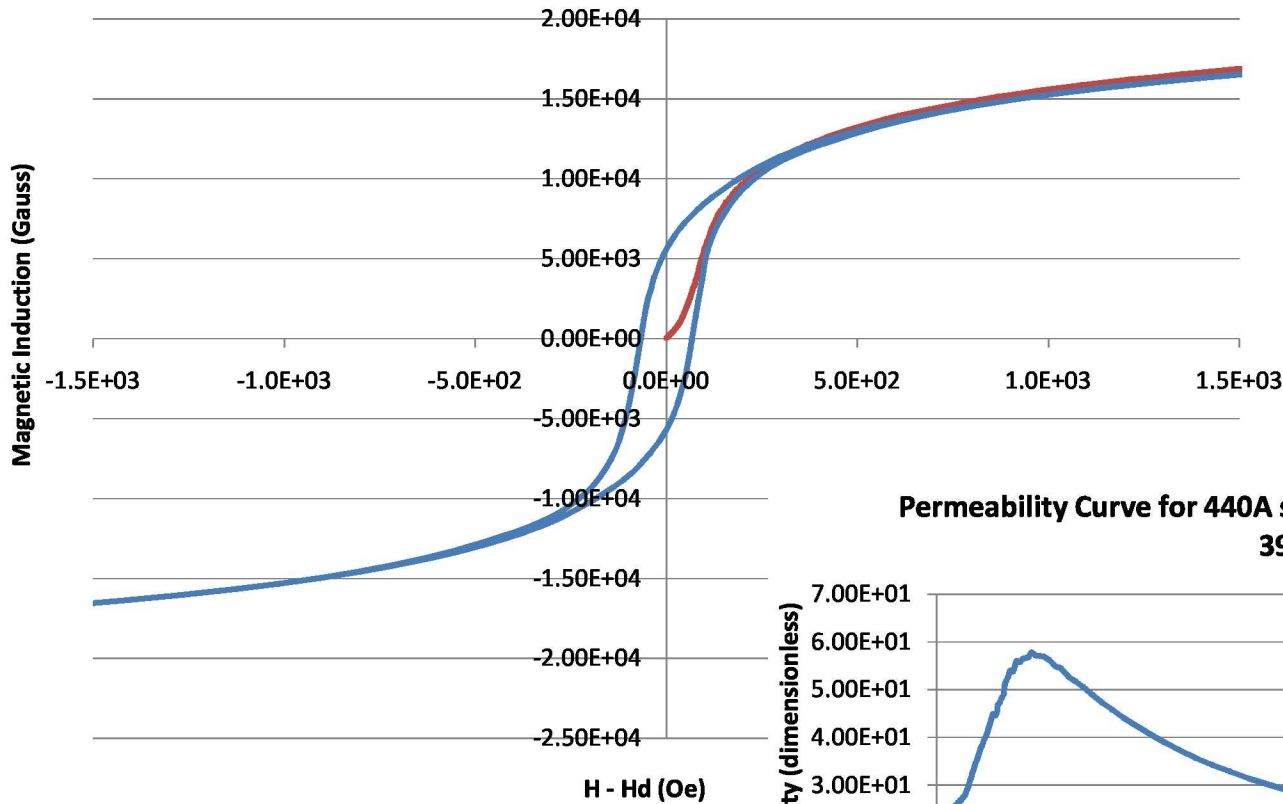
## Hysteresis Loop for 440A Poppet Steel From Poppet Simulator S/N 39

The part has a low residual field during EC testing. At low levels of residual magnetic field, the relative permeability is measured to be about 25.

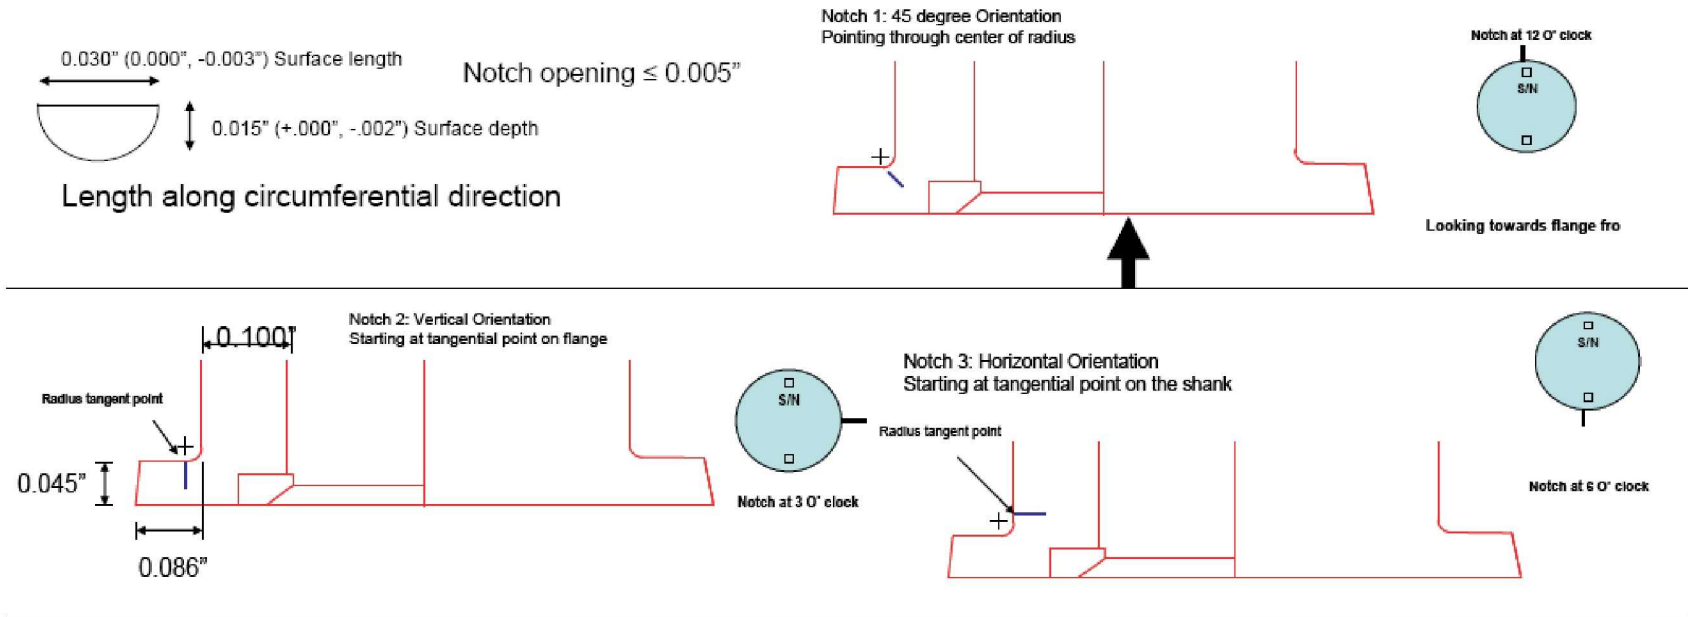
Each standard has three EDM notches

S/N 33 Poppet Standard

Poppet Simulator Standard (1 each)

A286 Poppet Standard

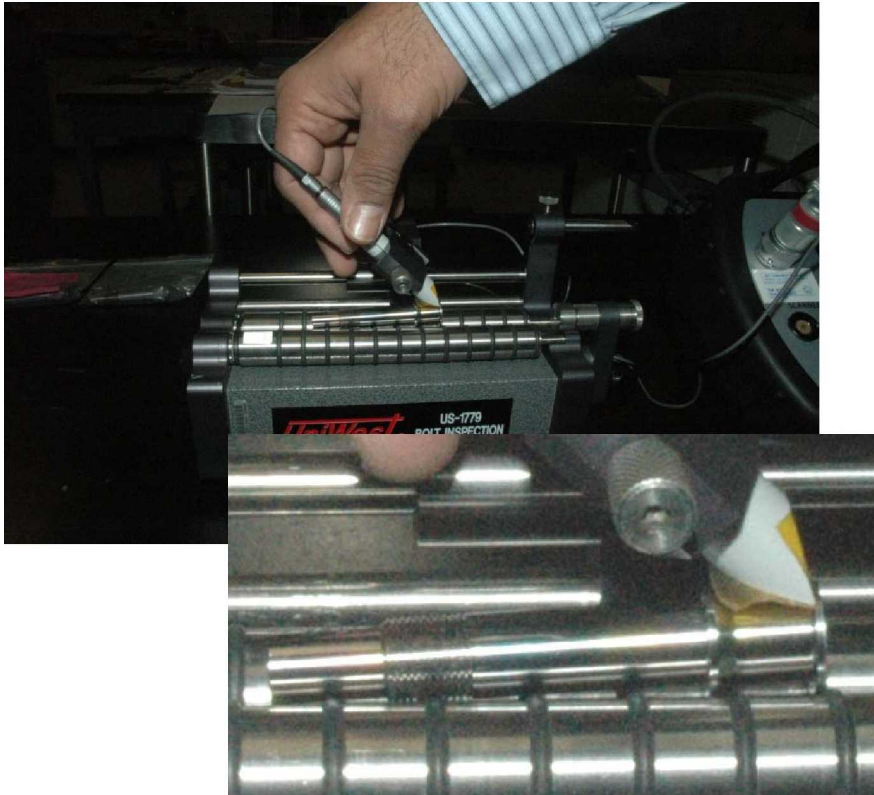
US 1779 (Uniwest) Bolt Inspection Scanner

Ti Bolt Standard with Circumferential Notches

Frequency: 2 MHz

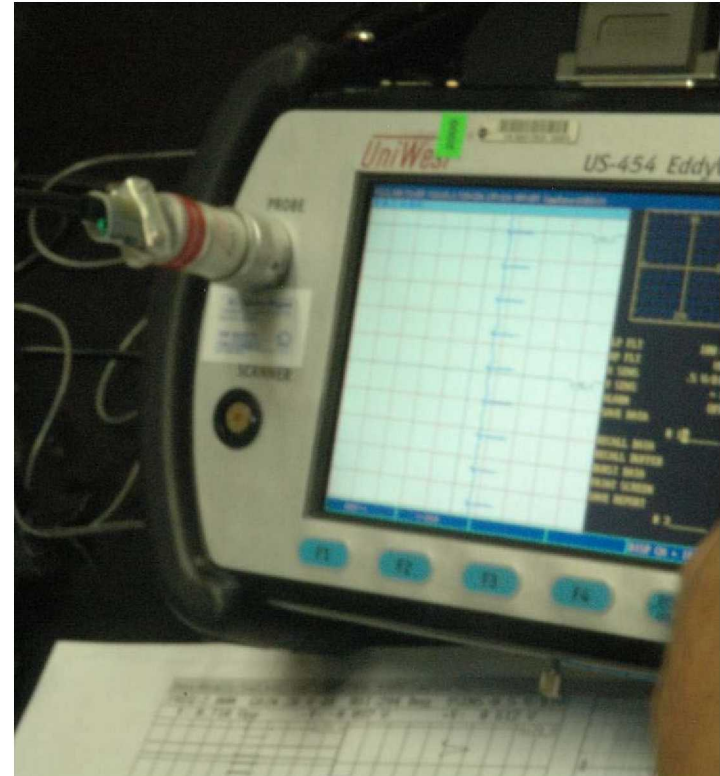
US-454 (UniWest) Eddy Current Flaw Detector

Driver-pickup  
construction  
0.08 inch  
spacing

Eddy Current Bolt Thread Root  
Inspection probe

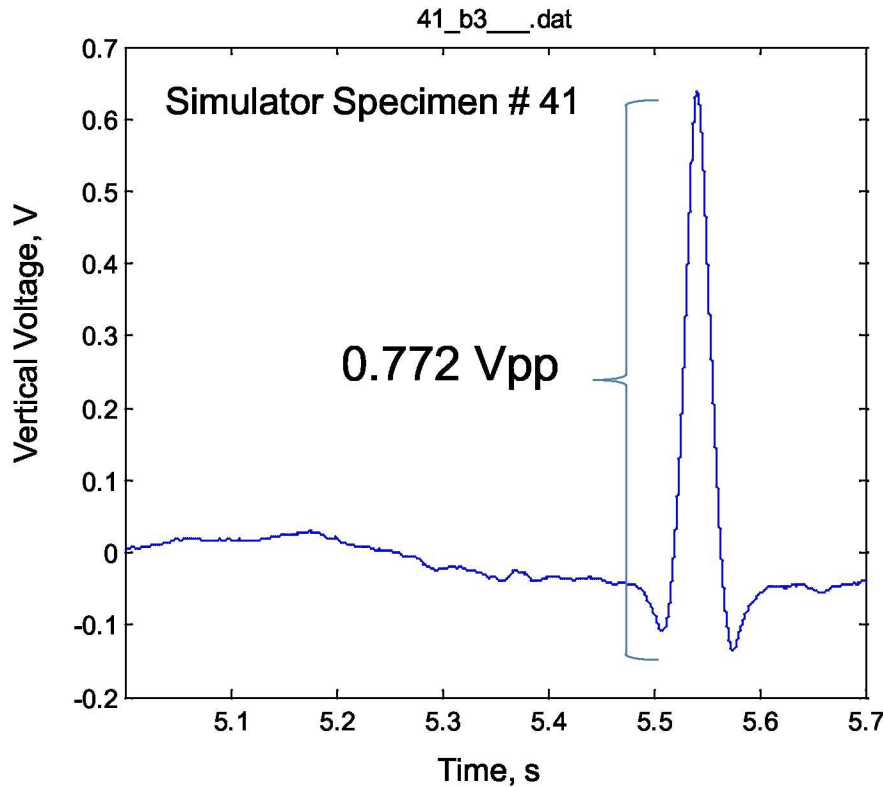
Time Scan: One revolution

Vpp – Positive peak to negative peak voltage

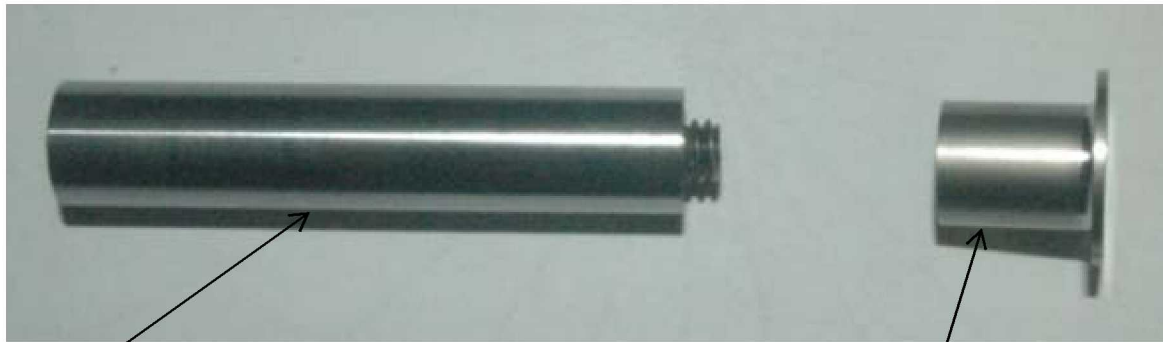
Simulator extender

Poppet simulator

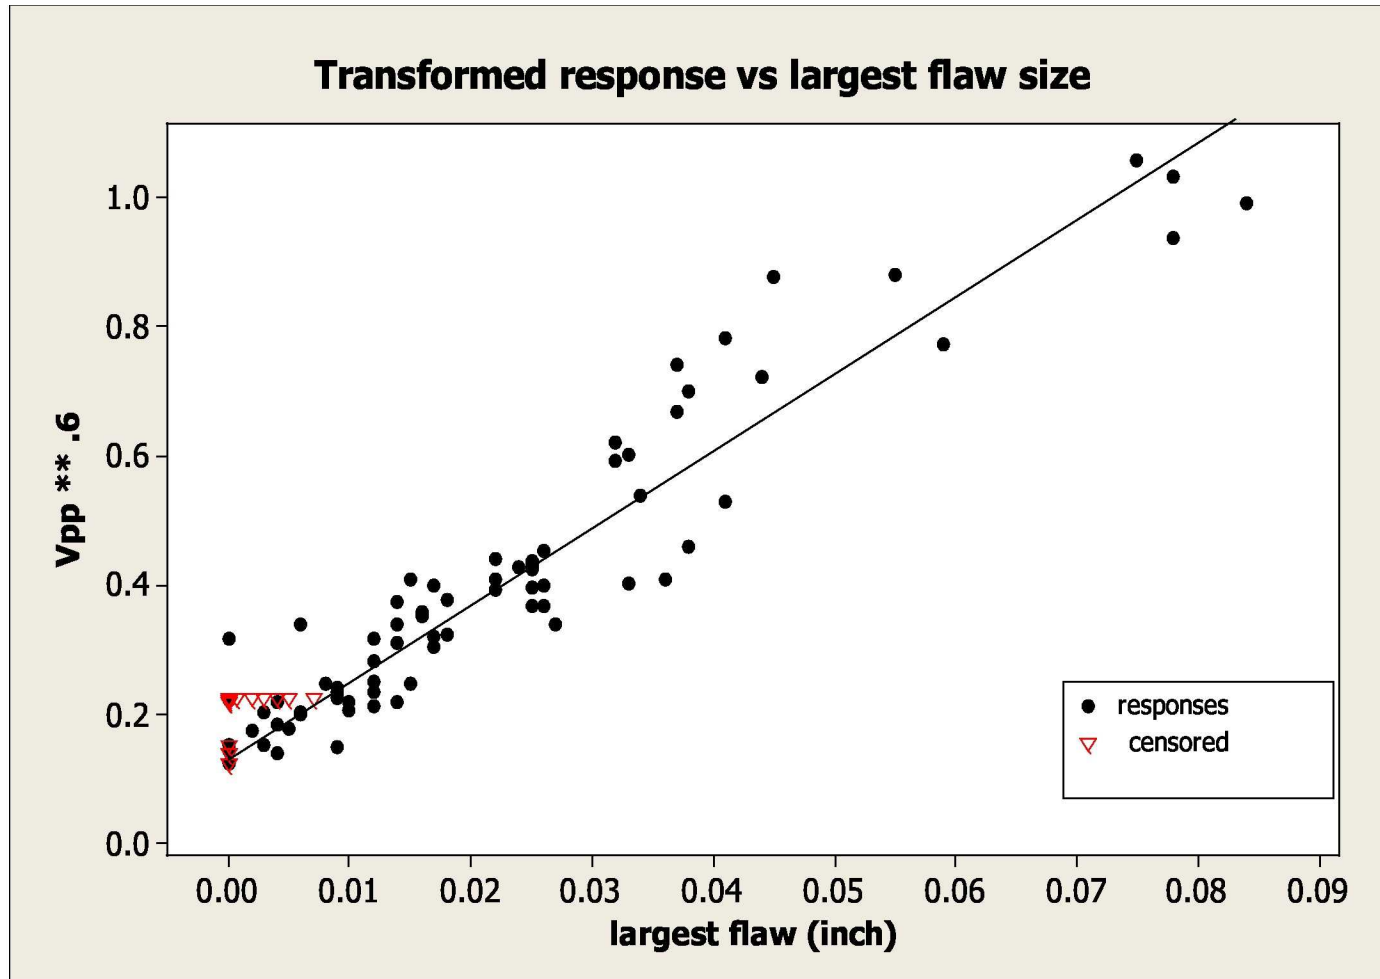
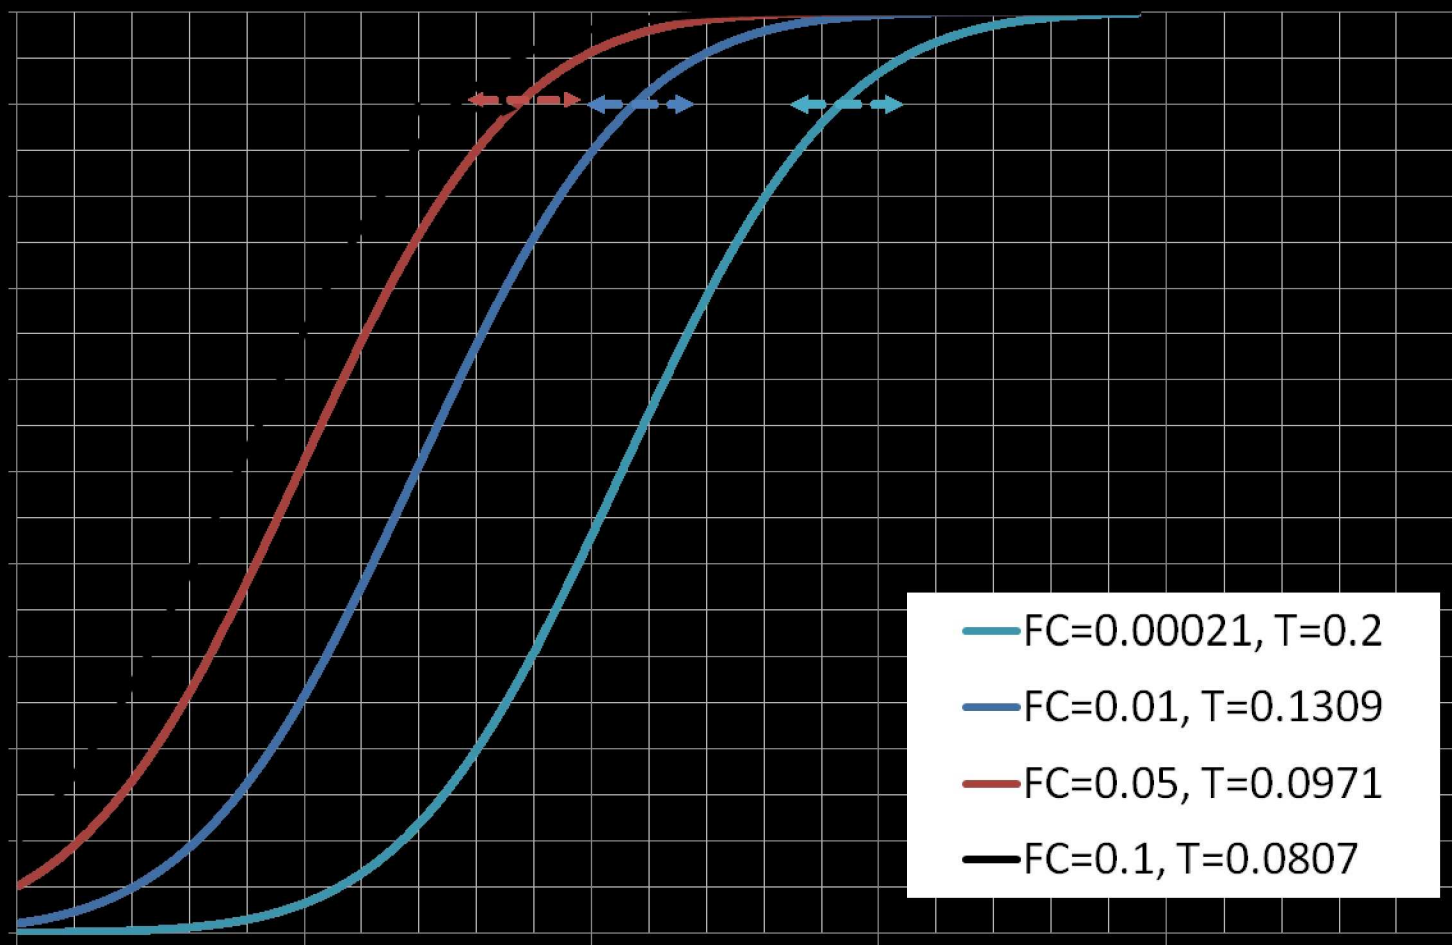
$$V_{pp}^{.6} = 0.1299 + 11.9398 \cdot \text{flaw size}$$

$$\delta = 0.0712$$

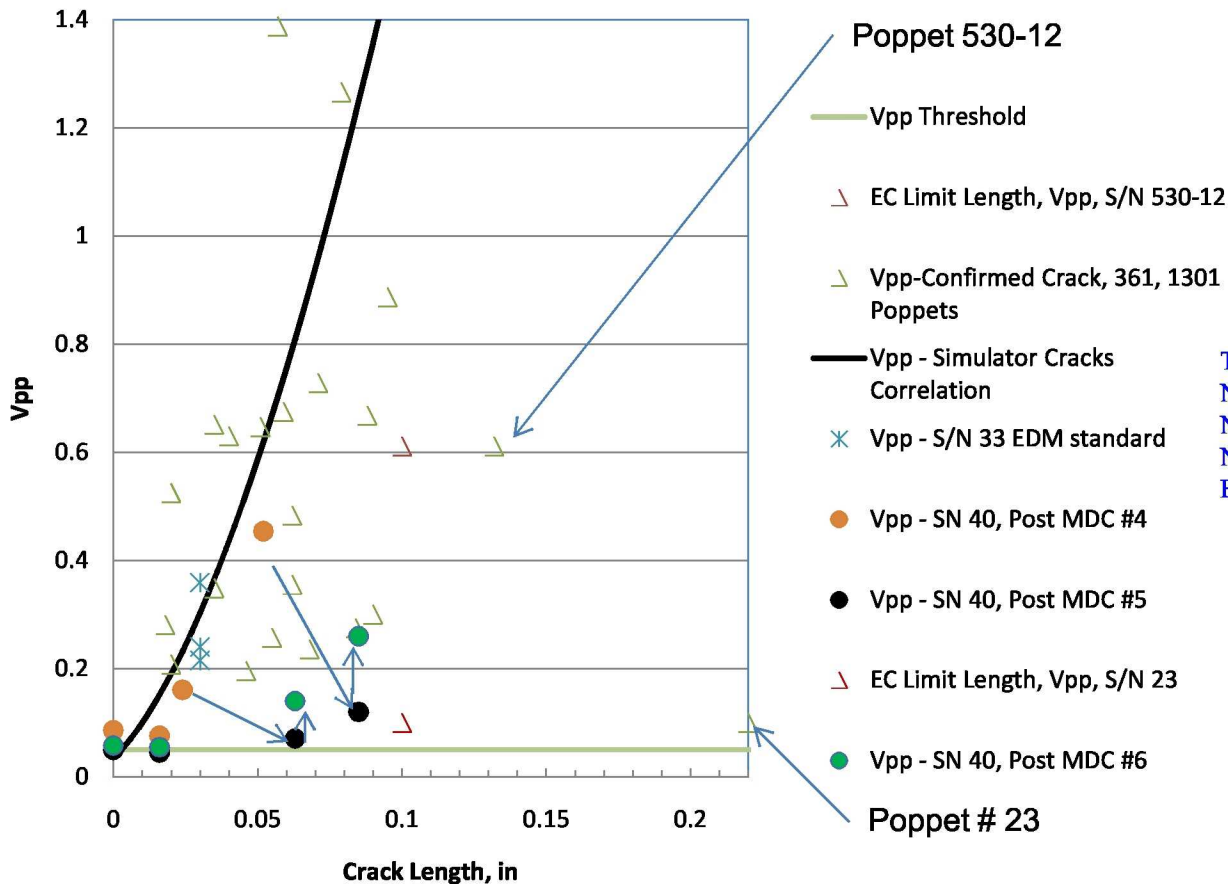
**Titanium Bar (4% IACS) EDM Notch Responses**  
 Notch A: 0.210 Vpp 0.030" l X 0.015" d  
 Notch B: 0.536 Vpp 0.050" l X 0.025" d  
 Notch C : 0.829 Vpp 0.070" l X 0.035" d  
 EC Depth of penetration: 0.011"

•Note: The crack signal is saturated beyond a crack length of 0.1" approx.  
 •Therefore, two data points have been shown shifted to 0.1" limit length.

Simulator cracks (1 micron) are more open compared to the poppet cracks (0.25 micron). Simulator magnetic permeability = 25. The Vpp from the EDM notch of the S/N 33 poppet EDM standard provides response close to simulator response. Titanium standard provides slightly lower Vpp responses compared to the poppet simulator response. Higher responses have been observed for some cracks compared to the comparable EDM notches indicating Vpp change possibly due to the higher magnetic permeability at crack locations. Greater variation in poppet crack responses compared to the simulator responses.

**Acceptance criteria to account for the lowest crack responses from the poppets.**

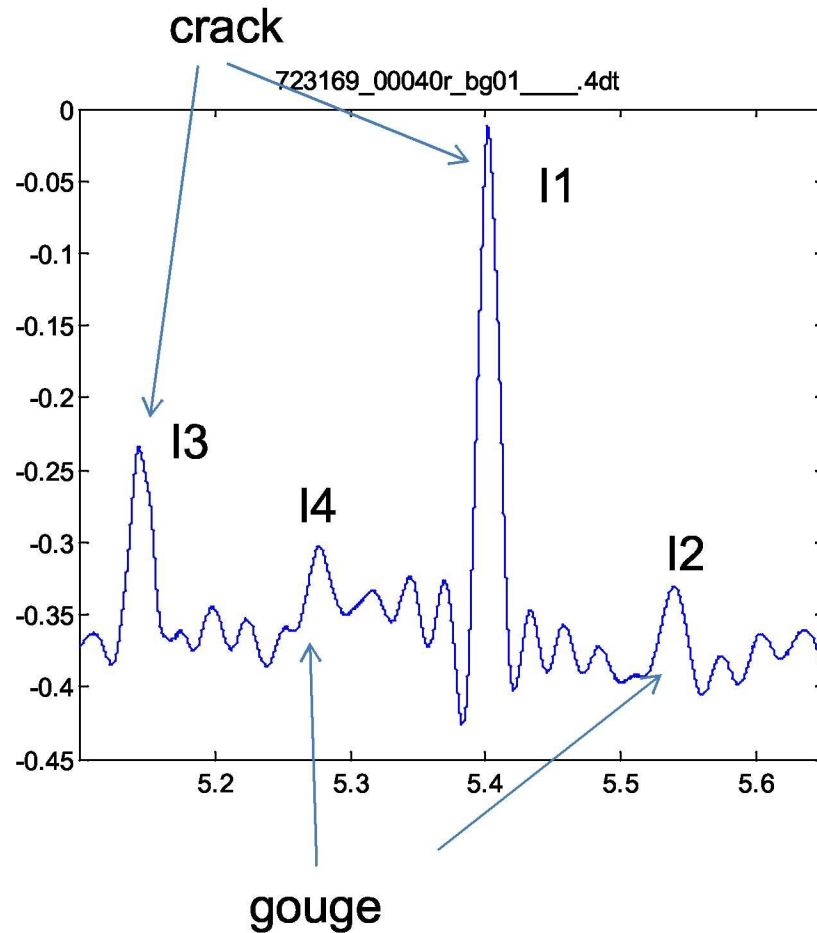
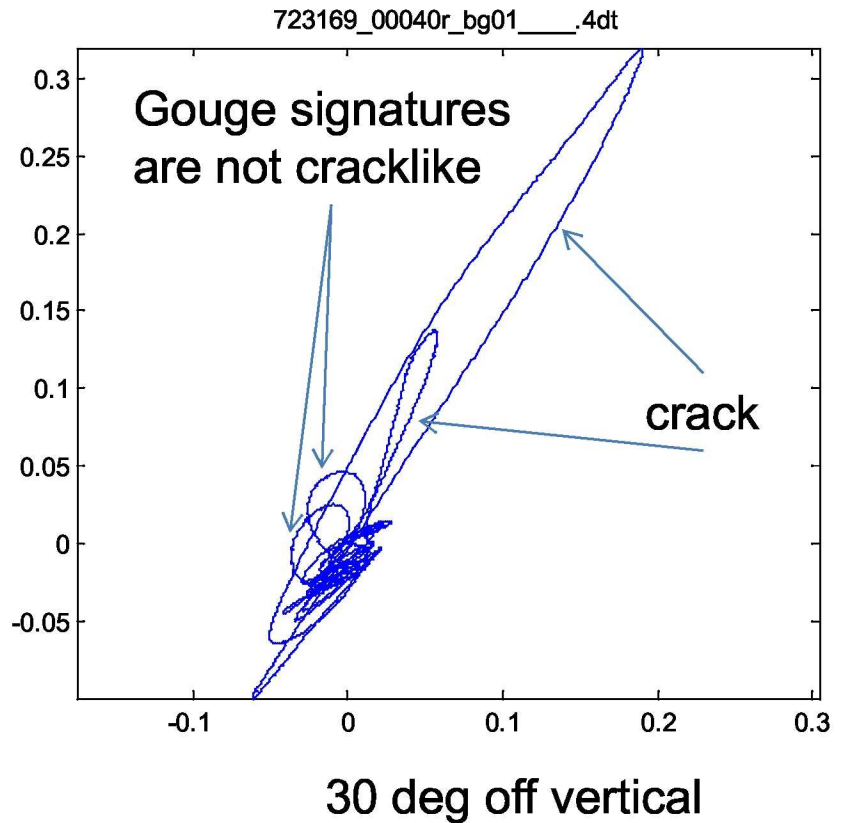
## Poppet 40 Post MDC #4

Gouge signatures are not cracklike. They can mask small crack signatures.

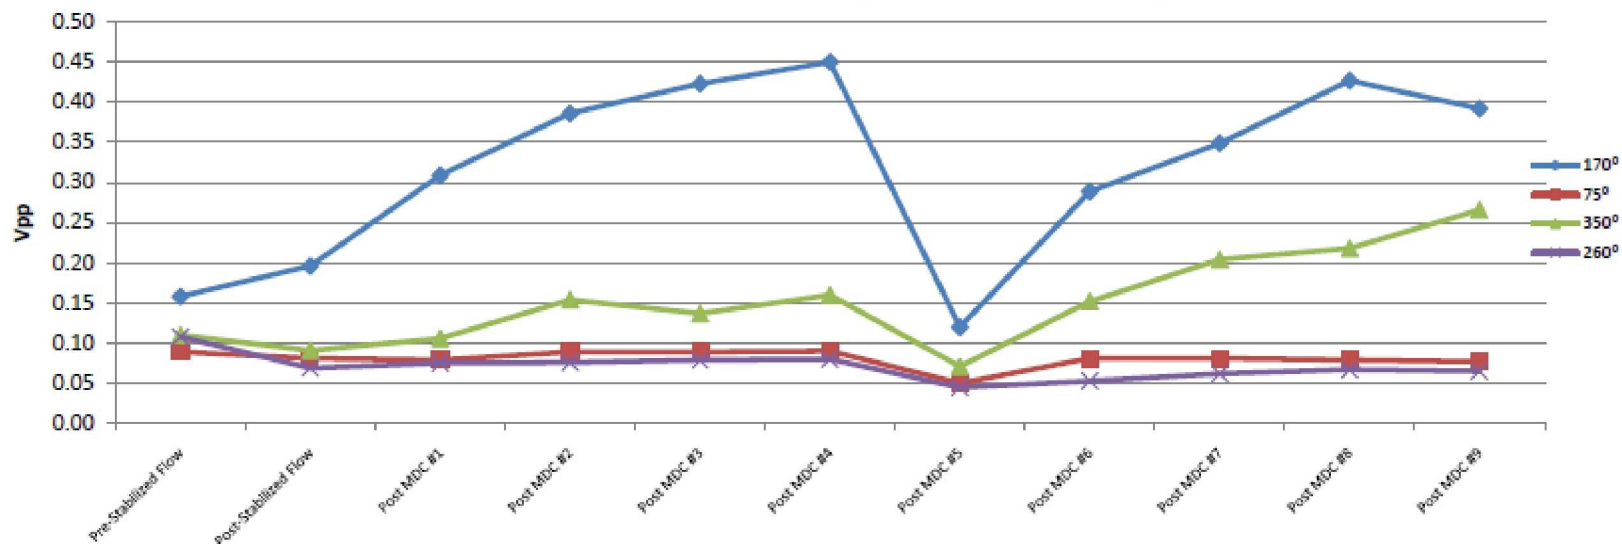
Inspection Phase	Eddy Current Vpp (MatLab Processed)				SEM Indication Length (inches)				
	Indication ID	1	2	3	4	1	2	3	4
	(Clock Position)	170°	75°	350°	260°	170°	75°	350°	260°
Pre-Stabilized Flow		0.158	0.089	0.11	0.108	0.050	0.200	0.024	0.016
Post-Stabilized Flow		0.196	0.081	0.091	0.069	0.050	0.200	0.024	0.016
Post MDC #1		0.309	0.079	0.106	0.075	0.052	0.200	0.024	0.016
Post MDC #2		0.386	0.089	0.154	0.076	0.052	0.200	0.024	0.016
Post MDC #3		0.423	0.089	0.137	0.079	0.052	0.200	0.024	0.016
Post MDC #4		0.45	0.09	0.16	0.08	0.052	0.200	0.024	0.016
Post MDC #5		0.12	0.05	0.071	0.045	0.085	0.200	0.063	0.016
Post MDC #6		0.289	0.081	0.152	0.053	0.085	0.200	0.063	0.016
Post MDC #7		0.349	0.081	0.204	0.062	0.085	0.200	0.063	0.016
Post MDC #8		0.427	0.079	0.218	0.067	0.085	0.200	0.063	0.016
Post MDC #9		0.392	0.077	0.266	0.065	0.085	0.200	0.063	0.016

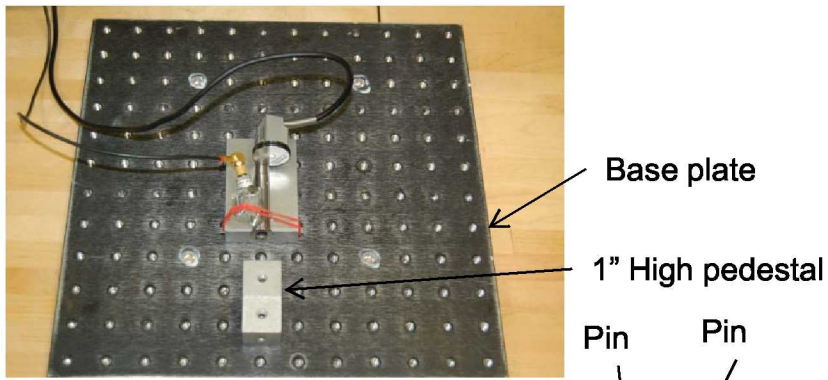
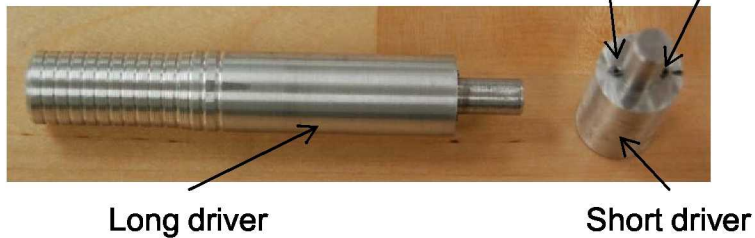
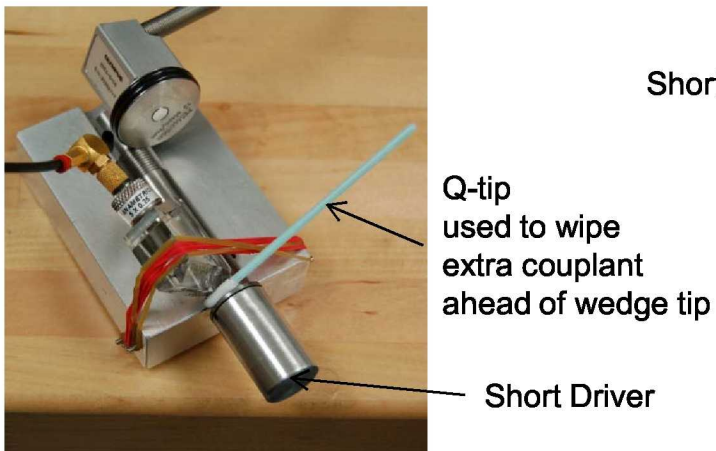
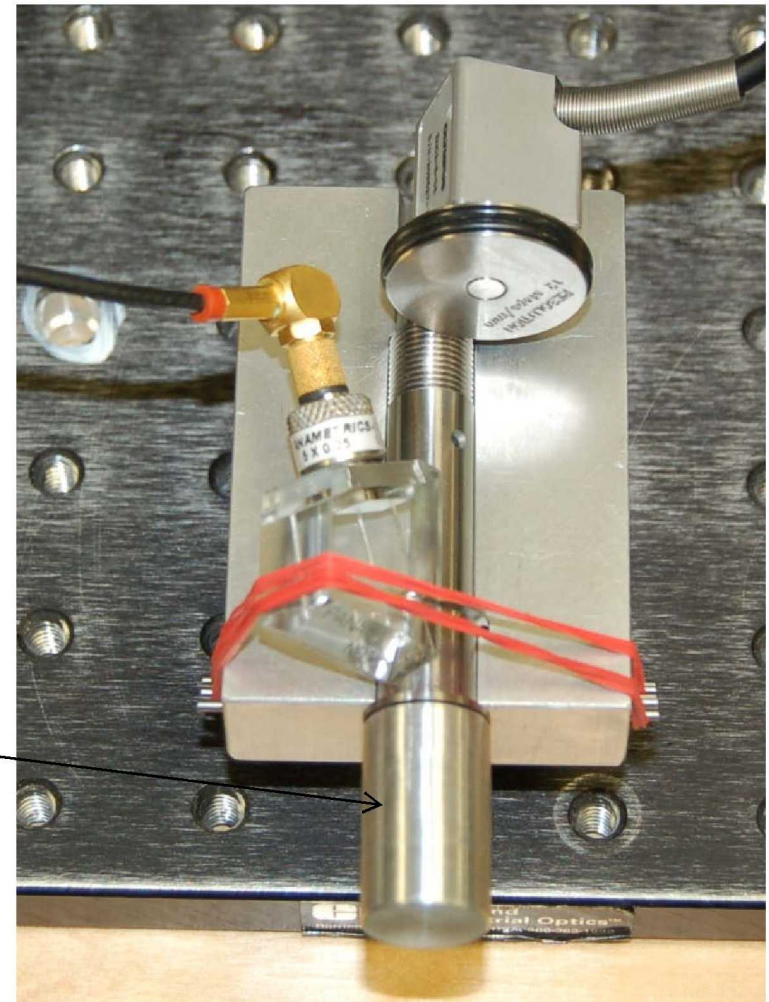
Uses contoured wedge

Detects cracks longer than 0.050"

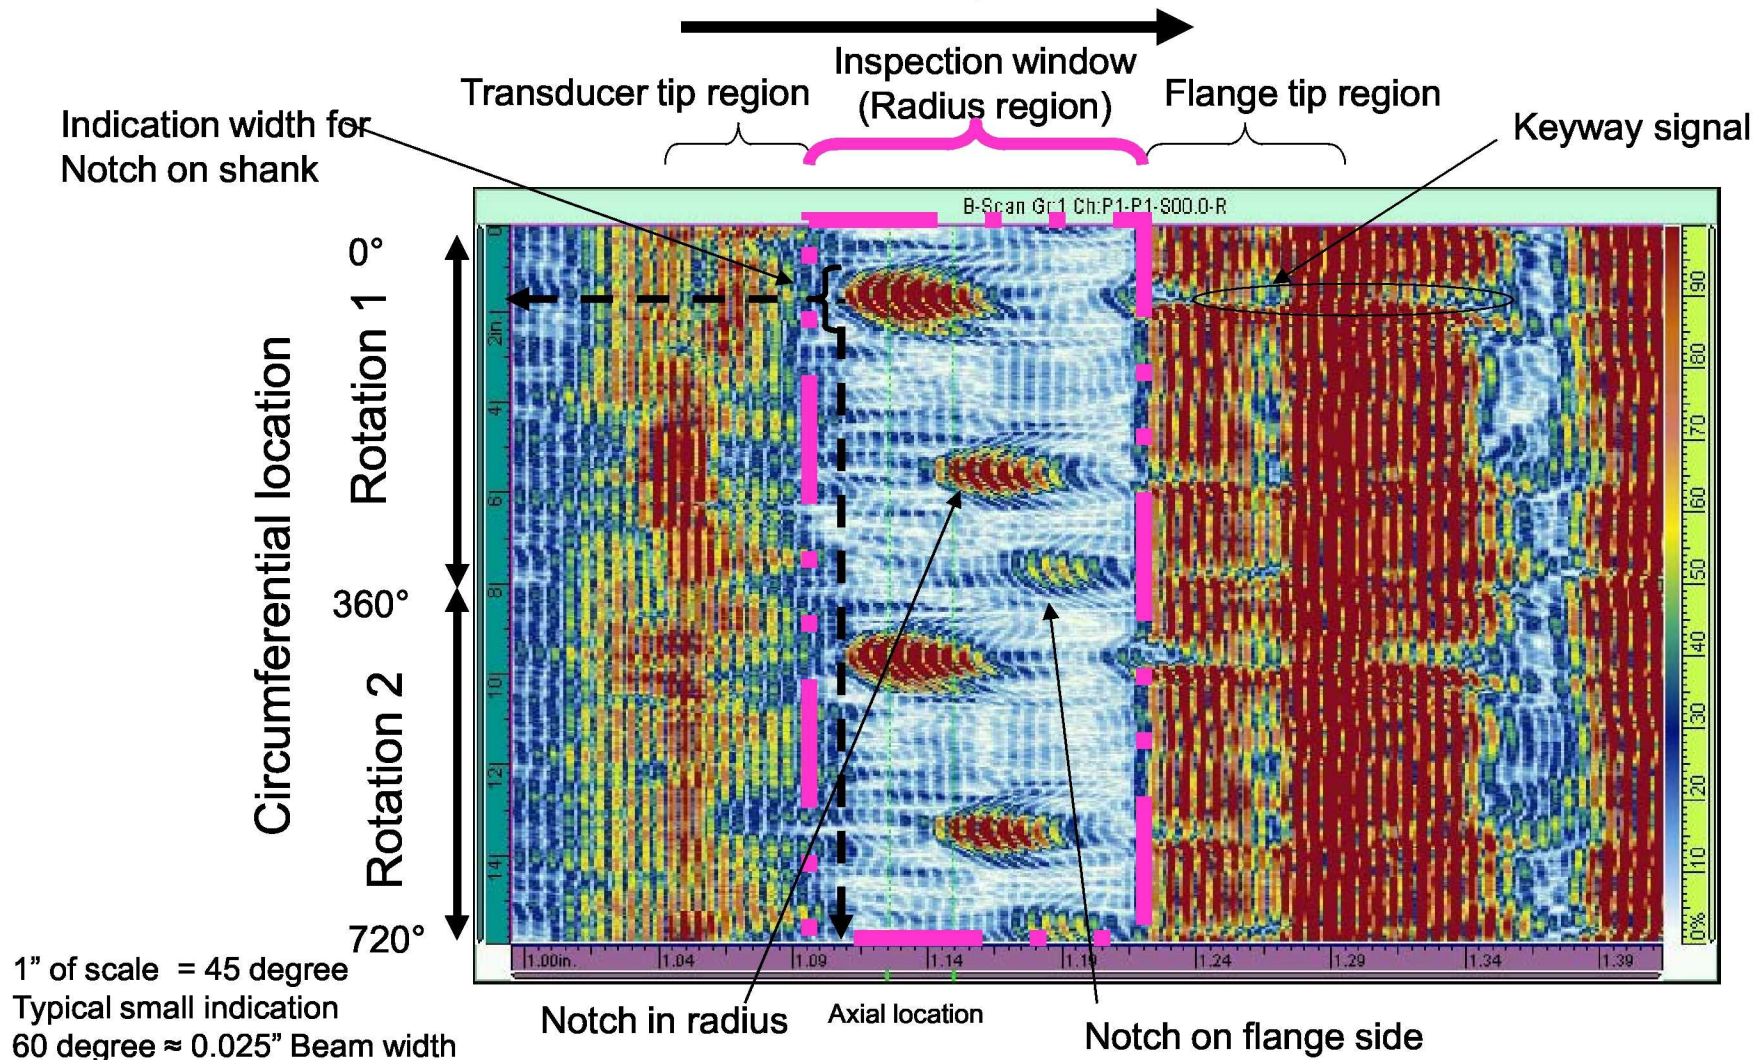
Surface distance along axial direction or pulse time

Two rotations of data acquisition to establish consistency in results
